COLUMN SHELL CORROSION PROTECTION VERIFIED

External inspection during operation confirms critical process asset integrity, preventing forced shutdown and saving \$millions.

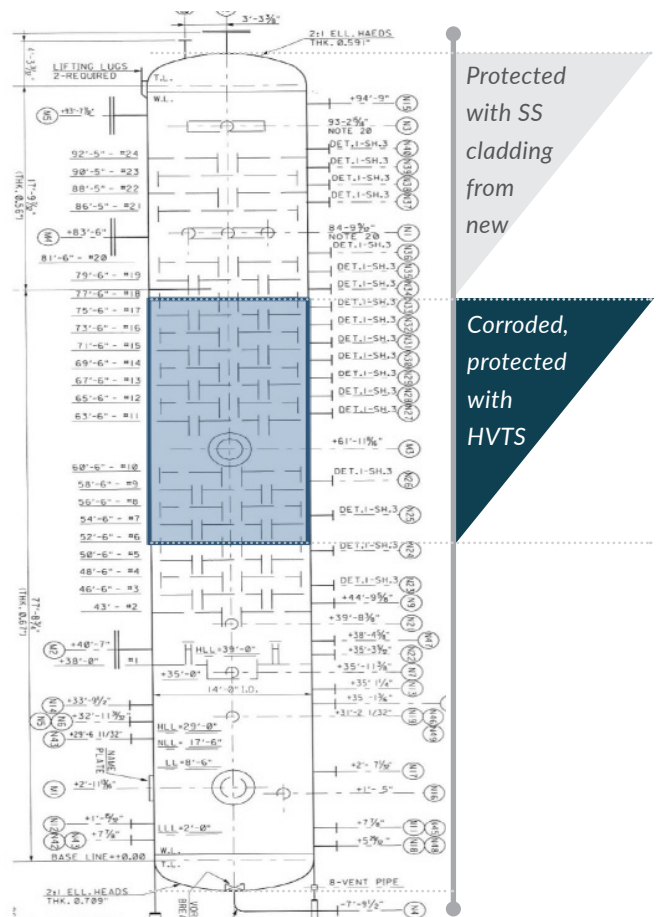
GA drawing of the Train 2 Stripper Column

This case study focuses on the HVTS alloy cladding application performed on one of the two trains at this asset owner's gas plant in 2016. Corrosion in that train (Train 2) was more aggressive than in its companion (Train 1) where the same scope was completed a year before. IGS HVTS was applied on a 140m² area between trays 6 and 18.

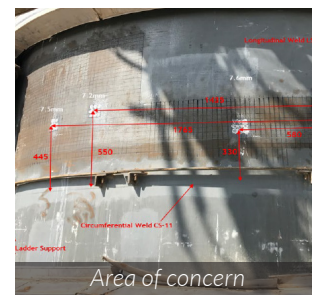
The plant operator continued to perform regular external NDT/UT inspections to monitor the column shell thickness. In 2018, two years after the HVTS application and two years before the next scheduled shutdown in 2020, they started recording readings between trays 15 and 17 that seemed to indicate a loss of shell thickness. An emergency forced shutdown was being considered to allow for an internal inspection to verify the corrosion barrier's (IGS HVTS cladding) integrity.
