COLUMN SHELL CORROSION PROTECTION VERIFIED

External inspection during operation confirms critical process asset integrity, preventing forced shutdown and saving \$millions.

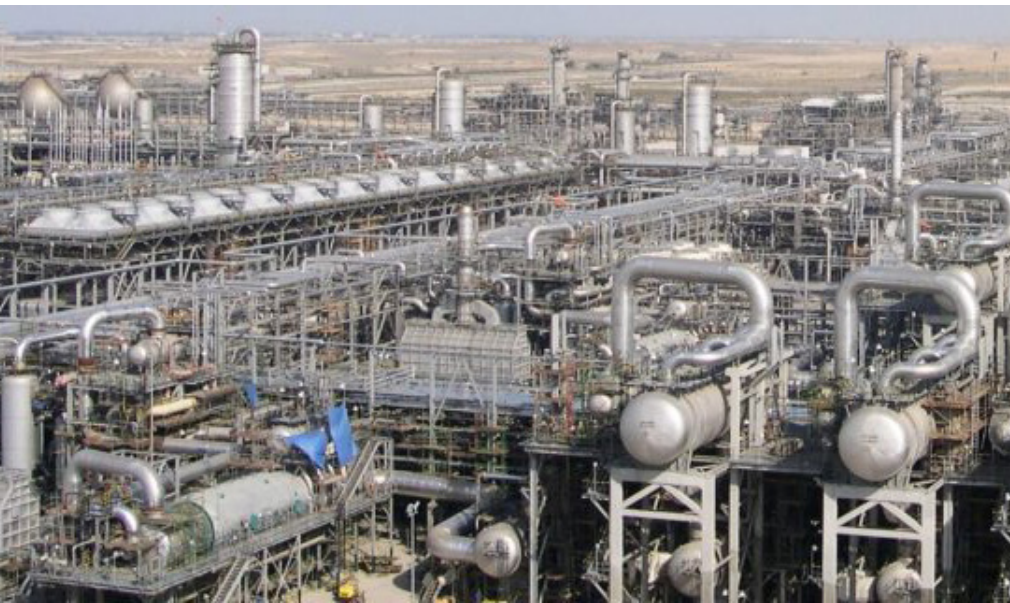
PROBLEM: Pitting corrosion identified inside a process column in an area below the stainless steel cladding.

PROBLEM? Asset owner's external inspection after 2 years in service suggested further internal metal wastage.

SOLUTION: IGS HVTS alloy cladding was applied to protect the damaged area from further metal wastage.

SOLUTION! IGS proprietary external inspection confirmed the integrity of the internal HVTS corrosion barrier, avoiding an unplanned forced shutdown.
