Putting a STOP to HFO Boiler Emergency Shutdowns!

Preventing HFO boiler fireside corrosion with HVTS alloy cladding

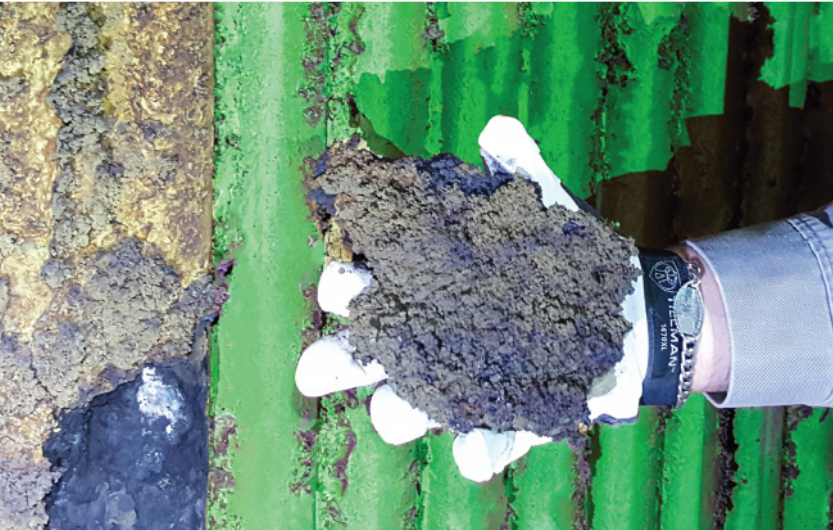
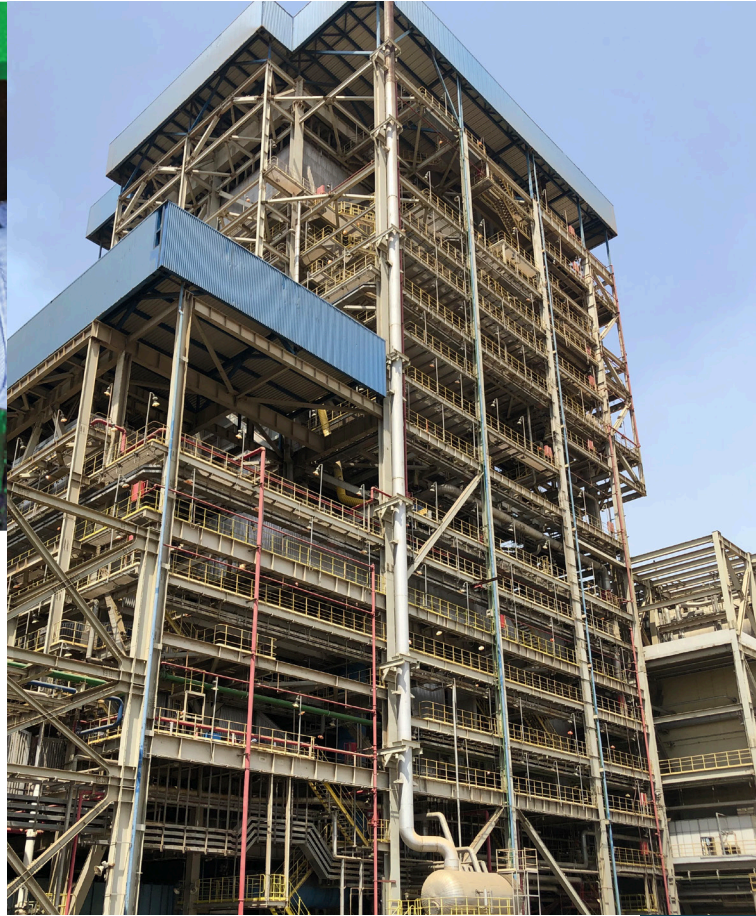
Fireside Corrosion in HFO Boilers

This power plant, located in Saudi Arabia, operates 2 X 602MW HFO boilers. The boilers were suffering from regular tube leaks and subsequent emergency shutdowns due to fireside corrosion (under deposit corrosion from Sulphur and Vanadium).

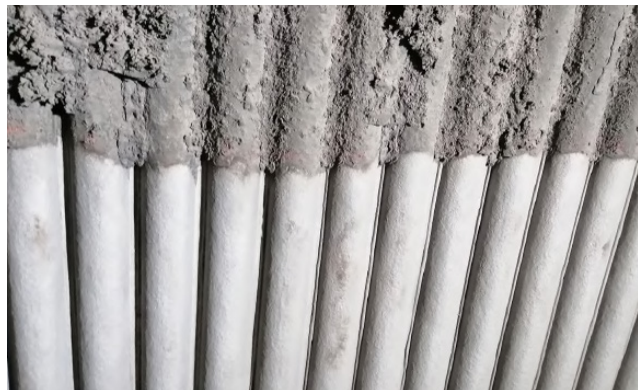
IGS HVTS Alloy Cladding Solution

IGS has a long and successful track-record of protecting HFO boiler internals suffering from high temperature corrosion attack, sulphidation, and under-deposit corrosion. This track-record, combined with the ability to rapidly mobilize equipment and highly skilled technicians for the application of an extremely high quality and robust protection system, makes IGS the ideal partner for power plant asset owners worldwide.
